MISCELLANEOUS PAPER S-69-13

# EVALUATION OF HARVEY ELECTRON BEAM WELDED AM2 LANDING MAT (AM2 MOD 2)

3. REPORT TITLE EVALUATION OF HARVEY ELECTRON BEAM WELDED AM2 LANDING MAT (AM2 MOD 2)			
4. DESCRIPTIVE NOTES (Type of report and inclusive dates) Final report

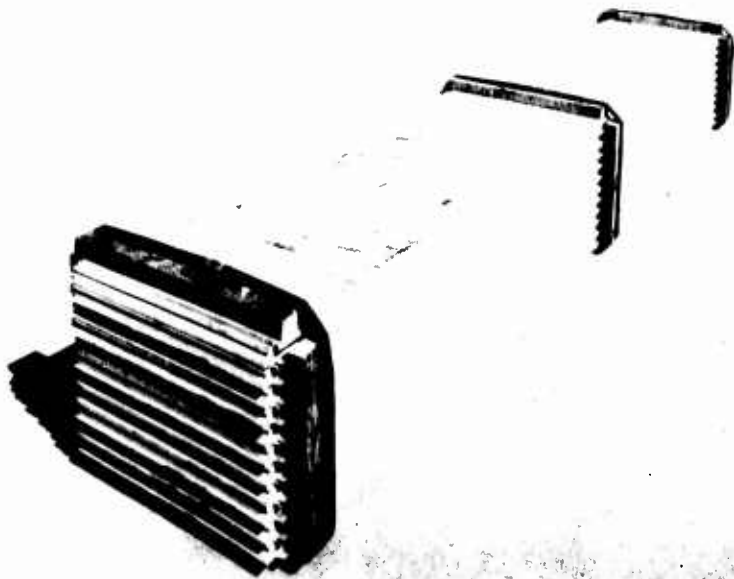
Fig. 1. Bundle of mat as received for testing

10. The AM2 mod 2 mats were received at the WES in four bundles, each weighing approximately 1590 lb. Full and half planks were packaged in each bundle. The mat planks, approximately 2 ft wide, were fabricated from one extrusion to which end connectors were then electron beam welded. (Electron beam welding is a new process being applied by Harvey.) The formed planks were 12.08 and 6.08 ft long for the full and half planks, respectively, with an average thickness of 1.5 in. The top surface of the planks

A mat bundle is shown in fig. 1, and a whole and a half plank are shown in fig. 2.

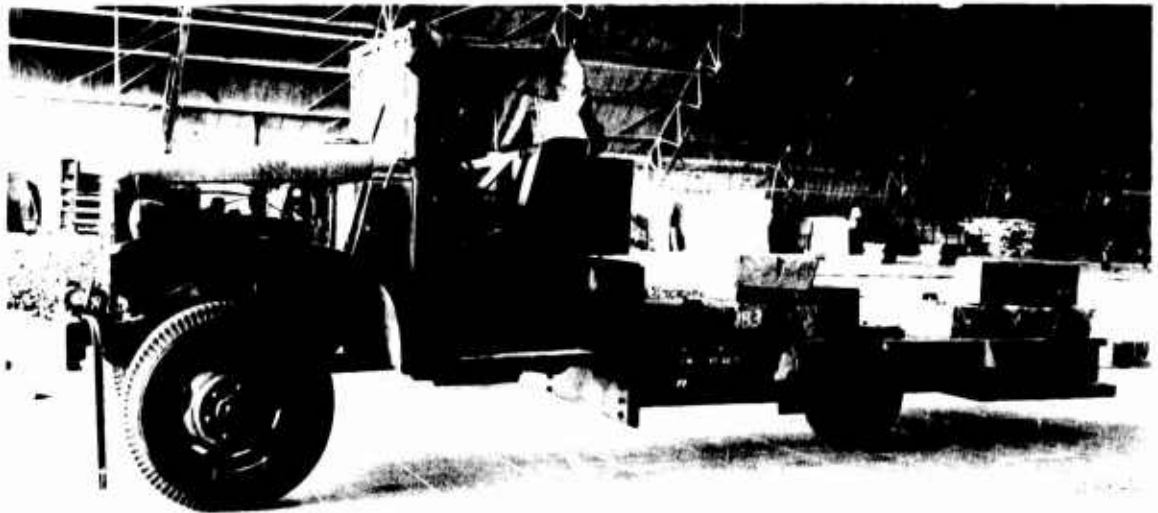
Fig. 3. Load cart used in traffic tests: 27,000-lb single-wheel load, 400-psi tire pressure, and 82-sq-in. tire contact area

13. A specially designed single-wheel test cart (fig. 3) loaded to 27,000 lb was used in the traffic tests. It was equipped with an outrigger wheel to prevent overturning and was powered by the front half of a four-wheel-drive truck. The load cart was equipped with the specified 30-7.7 18-ply rating tire inflated to 400 psi. For the 27,000-lb wheel load, the tire had a contact area of about 82 sq in. and an average contact pressure of 330 psi.

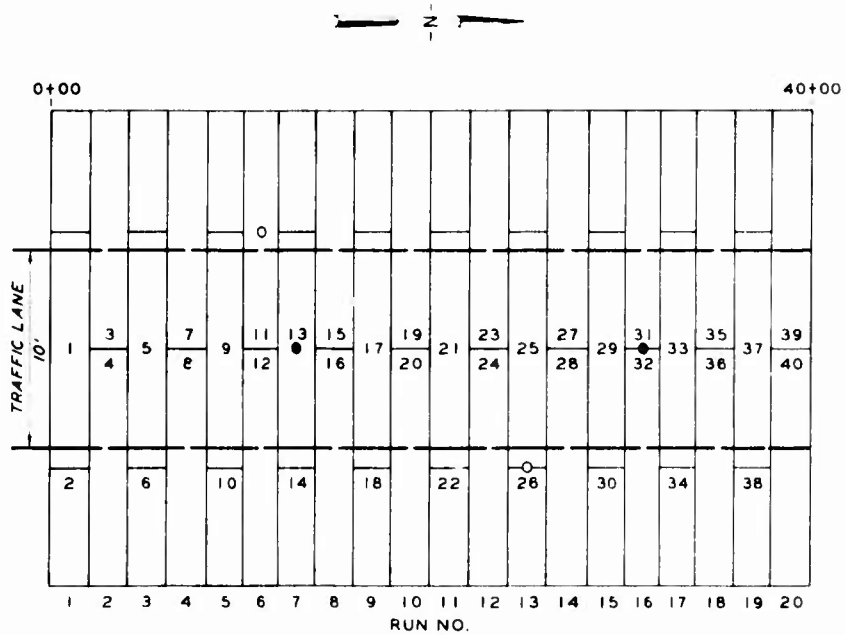
PLAN AND  
SUBGRADE PROFILE

NOTE: NUMBERS INSIDE PLANKS  
INDICATE PLANK NUMBERS

8. A layout of the test section is shown in plate 1. The test section was approximately 40 ft long and 24 ft wide. The subgrade was constructed of a heavy clay soil. Classification data for the subgrade soil are shown in plate 2.

12. The entire test section was surfaced with AM2 mod 2 mat placed with the long axis perpendicular to the direction of traffic (plate 1). The surfaced test section was approximately 24 ft wide. The first run of mat consisted of one full plank in the center with half planks on both ends, and the second run consisted of two full planks placed end to end. This alternating pattern was continued throughout the test section for 20 runs, or approximately 40 ft, and provided the staggered joint configuration shown in plate 1.

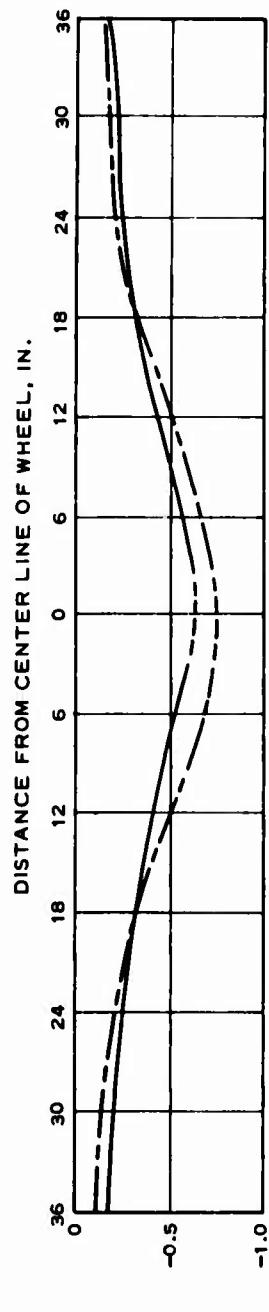
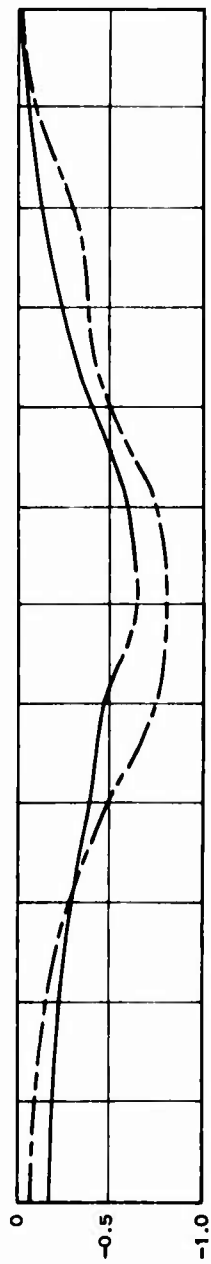
ELASTIC DEFLECTION OF MAT

CENTER OF PLANK

ON JOINT

22. Elastic deflections of the mat surface prior to and after traffic are shown in plate 5. These plots indicate the elastic deflection, or rebound, of the mat as the wheel load moved over the surface. The data for the first plot were taken with the load wheel centered on the midpoint of a plank, and the data for the second plot were taken with the wheel centered on the joint of two planks. In both cases, the load wheel was positioned in the center of the traffic lane.

23. The plots indicate that the change in elastic deflection over the trafficking period was negligible. The maximum deflection, about 0.80 in., occurred at the plank joint after 346 coverages. At 0 coverages the deflection at the same point averaged about 0.65 in.
